Manhole Inspection Summary

Manhole # S19G__030MH

Insp Date: **10/10/07 9:09 AM**

Location Address: **2042 VINE-FAYETTE**

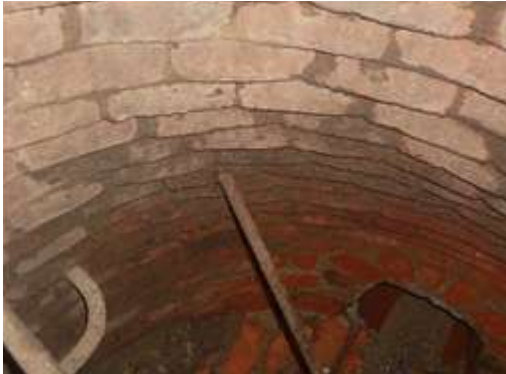
Defect 3

Infiltration: ☐ None ☐ Joint ☐ Cracks ☐ Mortar ☐ Roots ☒ **Wall**

INFILTRATION OF THE BARREL WALL

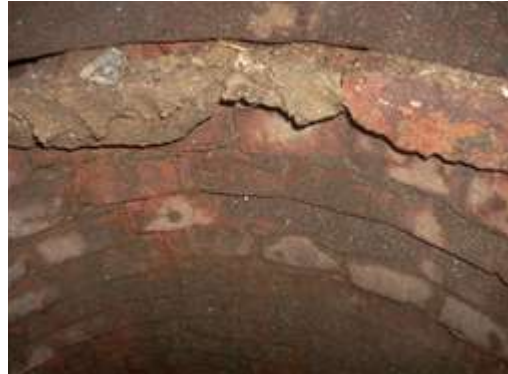
Defect 2

Infiltration: ☐ None ☒ **Joint** ☐ Cracks ☐ Mortar ☐ Roots ☐ Wall

INFILTRATION OF THE CORBEL JOIT

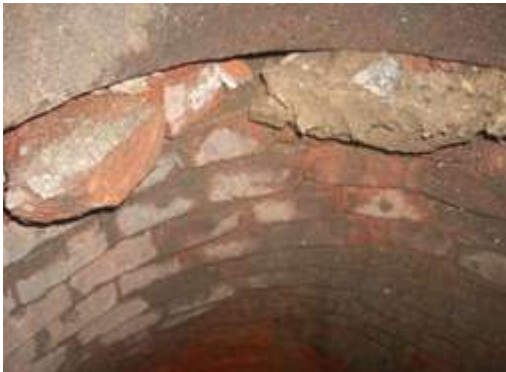
Defect 1

Condition: ☐ Sound ☐ Cracked ☐ Root Intrusion ☒ **Loose Brick** ☒ **Deteriorated**

DETERIORATED CHIMNEY WITH
LOOSE BRICKS

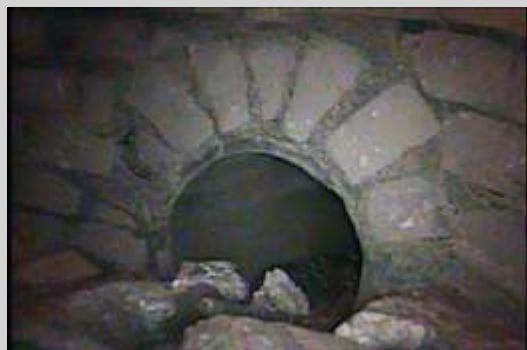
12 O'Clock Outflow

8 in. Circular Gravity Sewer
Pipe Out @ 12 O'Clock

Deposits: ☐ None ☐ Mud ☐ Sludge ☒ **Debris** ☐ Grease

Silt Depth: **2** (in.) Deposits Extent: **Light**
